**Flood Control Project Maintenance
Levee Inspections**

Fall 2009 Levee Maintenance Deficiency Summary Report

San Joaquin River Basin

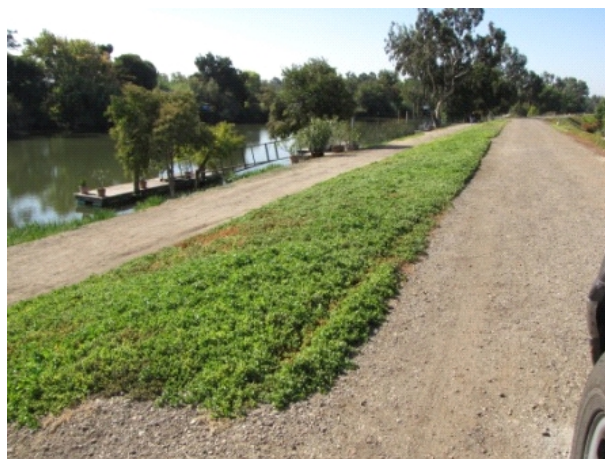
Levee Mile Report Line	161
Start Levee Mile	24.65
End Levee Mile	25.59
Location	Water Side
Category	Earthen Levee
Item	Encroachments

View of typical landowner planted and maintained landscaping and irrigation along the waterward shoulder and slope looking downstream.

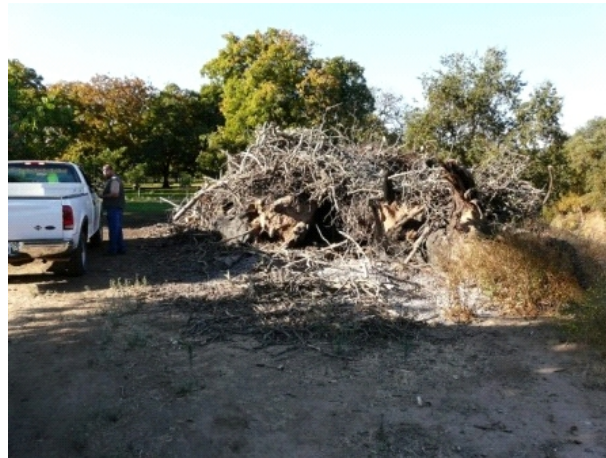
Levee Mile Report Line	1
Start Levee Mile	0.32
End Levee Mile	0.32
Location	Crown
Category	Earthen Levee
Item	Encroachments
<p>Prunings pile located at LM 0.32 on waterside shoulder of access road. The pile impedes access and forces vehicles to drive through orchard.</p>	
dpesaven_20091002_21.JPG

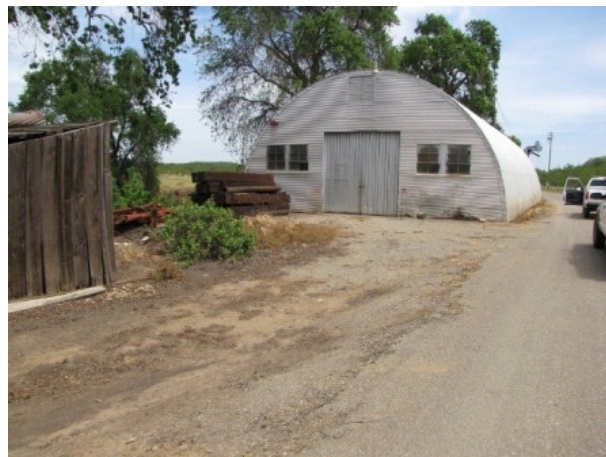
Levee Mile Report Line	2
Start Levee Mile	0.54
End Levee Mile	0.54
Location	Water Side
Category	Earthen Levee
Item	Encroachments
<p>Building/shed and other equipment located on waterward side of access road. There is no vehicle access adjacent to the channel.</p>	
dpesaven_20091002_27.jpg

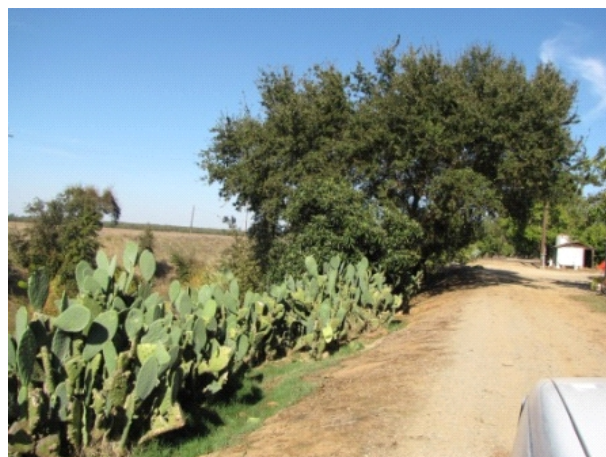
Levee Mile Report Line	4
Start Levee Mile	0.83
End Levee Mile	0.89
Location	Water Side
Category	Earthen Levee
Item	Encroachments
<p>View of landowner maintained landscaping on waterward side looking upstream.</p>	
dpesaven_20091028_323.jpg

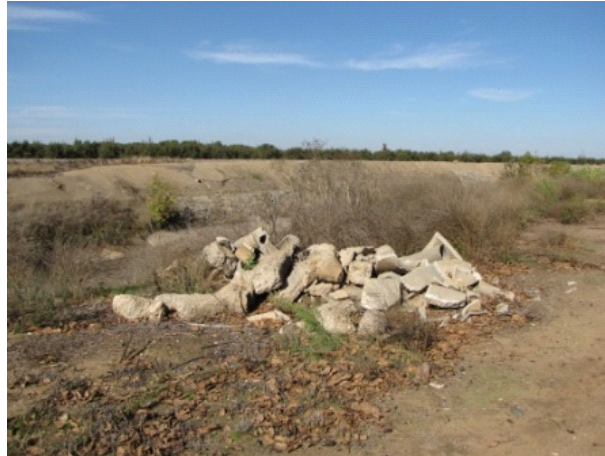
View of concrete debris on waterward side looking upstream.

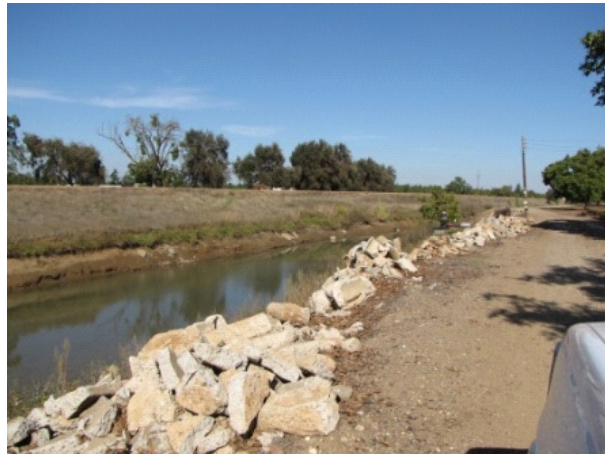
Levee Mile Report Line	8
Start Levee Mile	2.47
End Levee Mile	2.50
Location	Water Side
Category	Earthen Levee
Item	Encroachments

View of concrete debris on waterward side looking upstream.

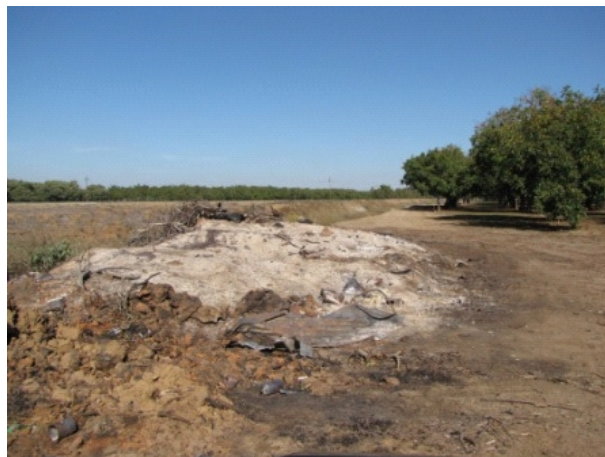
Levee Mile Report Line	11
Start Levee Mile	3.78
End Levee Mile	3.78
Location	Water Side
Category	Earthen Levee
Item	Encroachments

View of burn pile that has been burned and a location where a landowner recently removed prunings as requested looking upstream.

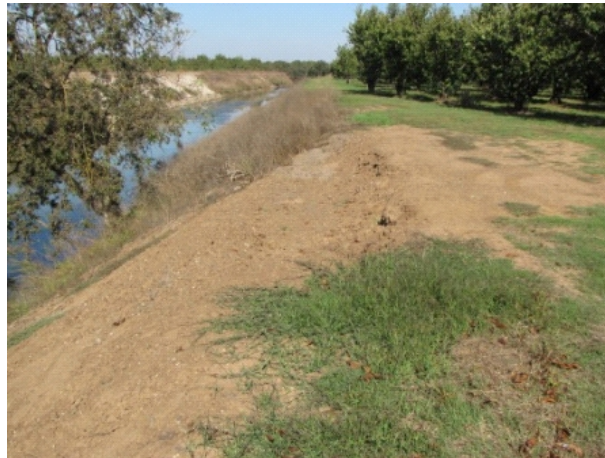
Additional view of repair site where material has slipped down looking upstream. This view is just upstream of the previous view.

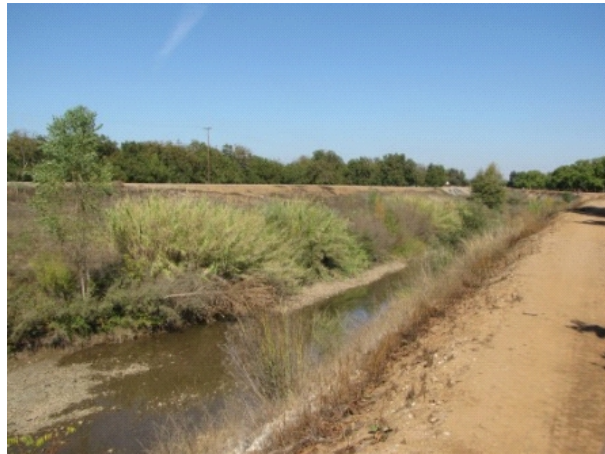
Levee Mile Report Line	16
Start Levee Mile	4.83
End Levee Mile	4.87
Location	Water Side
Category	Interior Drainage & Piping Systems
Item	Vegetation & Obstructions

View of vegetation in the channel impacting channel capacity and creating potential snags looking upstream.

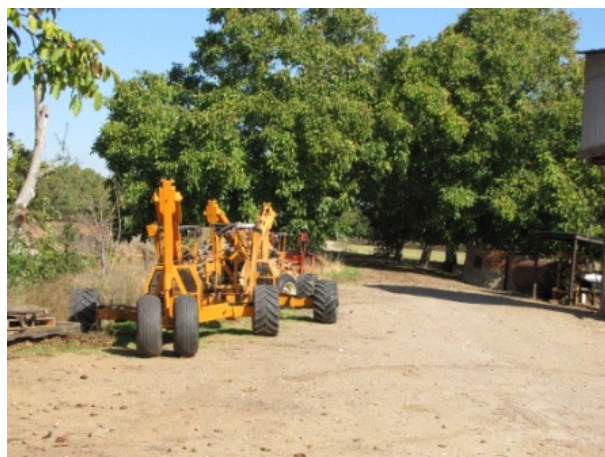
Levee Mile Report Line	19
Start Levee Mile	5.94
End Levee Mile	5.94
Location	Water Side
Category	Earthen Levee
Item	Encroachments

View of equipment located on the waterward side looking upstream.

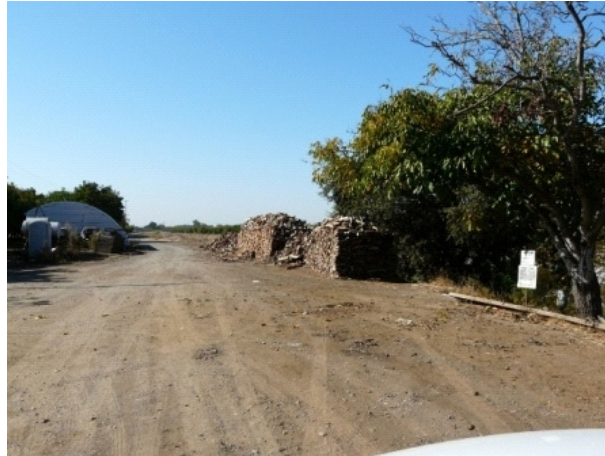
Firewood piles located on waterside of shoulder at LM 5.95. These piles should be moved away from landside of access road.

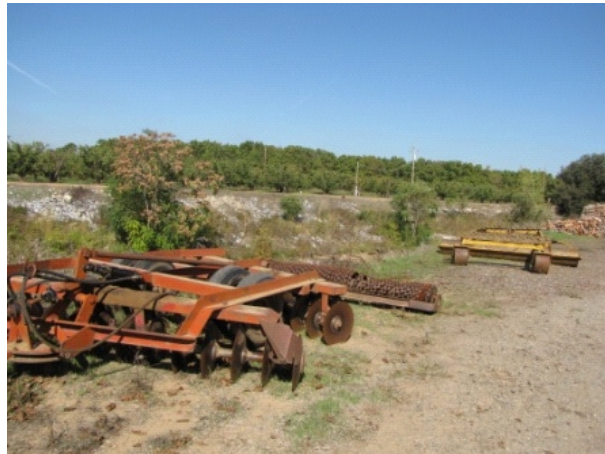
Levee Mile Report Line	21
Start Levee Mile	5.98
End Levee Mile	5.98
Location	Water Side
Category	Earthen Levee
Item	Encroachments

View of equipment located along the waterward side looking upstream.

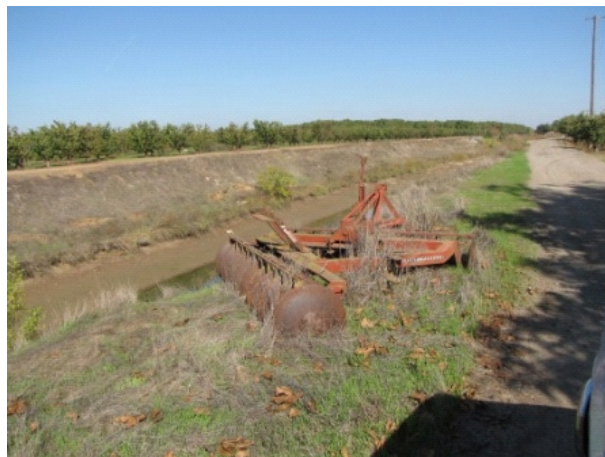
Levee Mile Report Line	22
Start Levee Mile	6.18
End Levee Mile	6.18
Location	Water Side
Category	Earthen Levee
Item	Encroachments

View of equipment on the waterward side looking upstream.

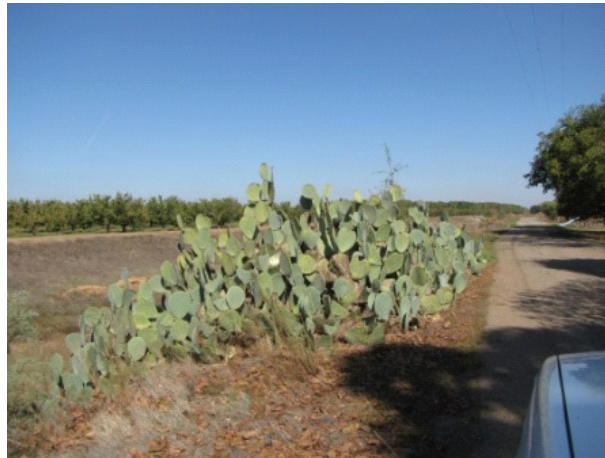
View of cacti located on waterward side looking upstream.

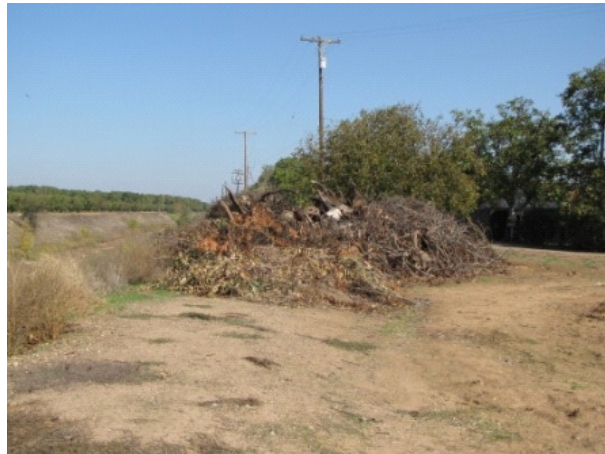
Levee Mile Report Line	24
Start Levee Mile	6.32
End Levee Mile	6.32
Location	Water Side
Category	Earthen Levee
Item	Encroachments

View of a large prunings pile on waterward side and access road blocking visibility and access looking upstream.

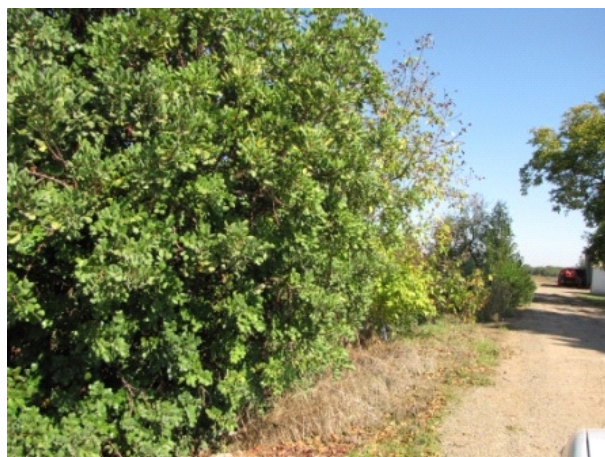
Levee Mile Report Line	26
Start Levee Mile	6.99
End Levee Mile	7.02
Location	Water Side
Category	Earthen Levee
Item	Encroachments

View of landowner planted and maintained landscaping and vegetation along the waterward side looking upstream.

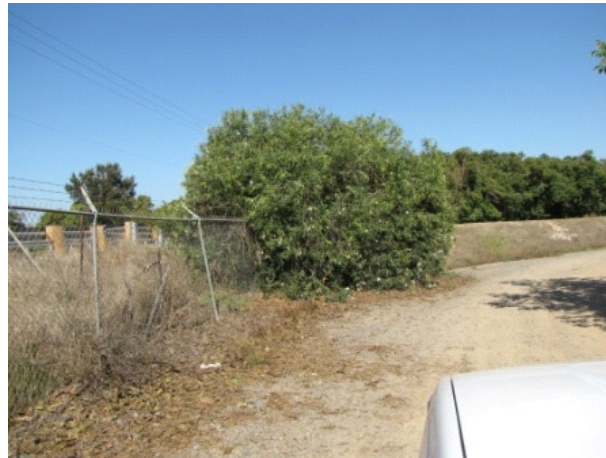
View of an oleander bush along the waterward side obstructing access and visibility.

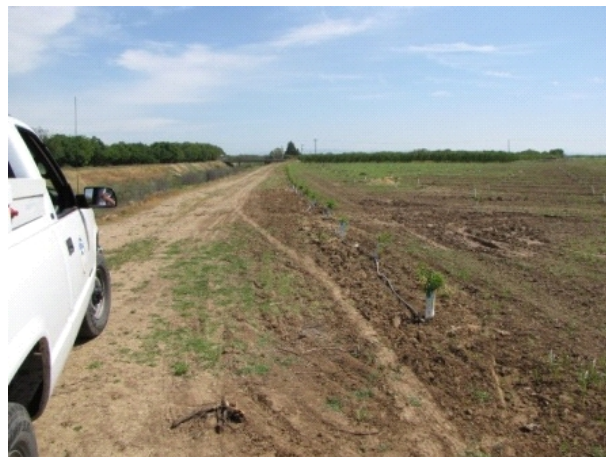
Levee Mile Report Line	28
Start Levee Mile	7.11
End Levee Mile	7.29
Location	Land Side
Category	Earthen Levee
Item	Encroachments

Recently planted trees are within 10' of landward toe of levee. These trees are an encroachment and are potentially future maintenance issues.

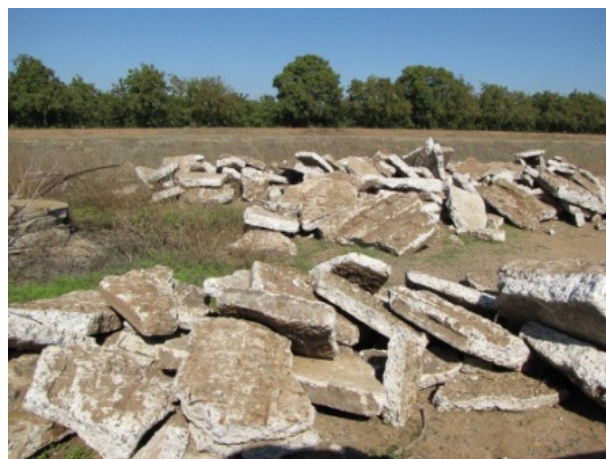
Levee Mile Report Line	29
Start Levee Mile	7.29
End Levee Mile	7.29
Location	Water Side
Category	Earthen Levee
Item	Encroachments

29	7.29	7.29	Earthen Levee	Encroachments	WS	M	Debris Inspector Comments: Concrete debris dumped on access road and waterward shoulder.	37.979682 ° -121.098319 °	37.979682 ° -121.098319 °	166 Y
30	7.30	7.30	Earthen Levee	Encroachments	WS	M	Prunings Inspector Comments: Burn pile has been burned but new material has been placed.	37.979522 ° -121.098305 °	37.979522 ° -121.098305 °	60

View of concrete debris obstructing access and visibility located on waterward side.

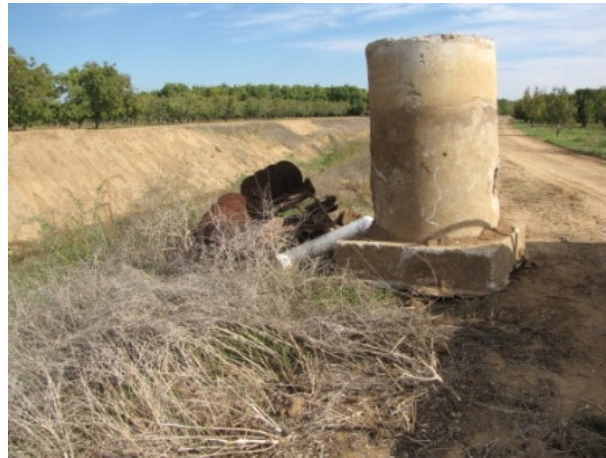
View of debris located on waterward side looking upstream.

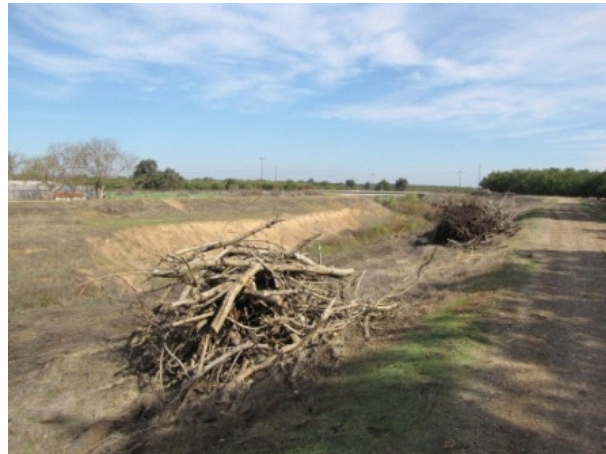
Levee Mile Report Line	36
Start Levee Mile	8.46
End Levee Mile	8.46
Location	Water Side
Category	Earthen Levee
Item	Encroachments

View of pruning piles located on waterward side looking upstream.

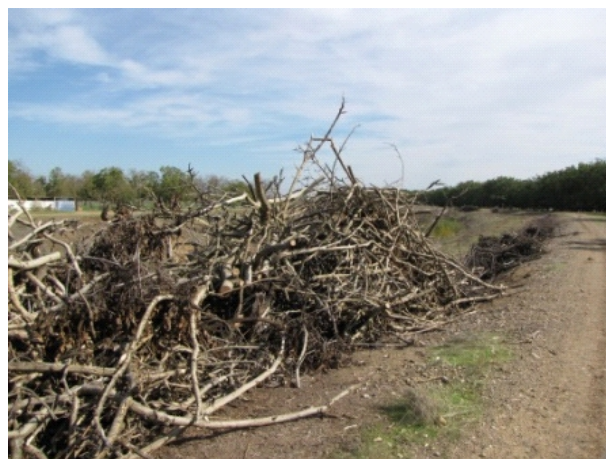
Levee Mile Report Line	37
Start Levee Mile	8.55
End Levee Mile	8.55
Location	Water Side
Category	Earthen Levee
Item	Encroachments

View of prunings located on waterward side looking upstream.

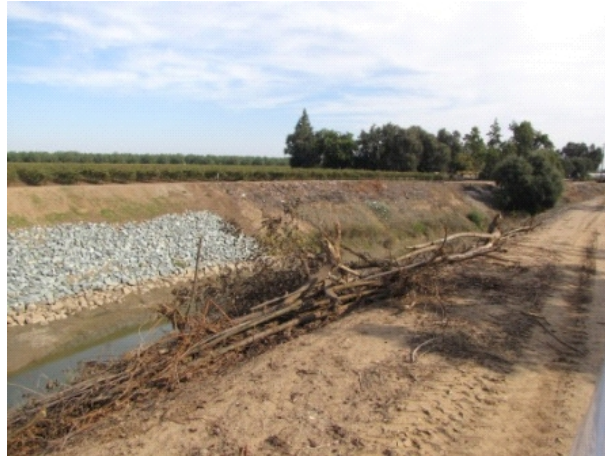
View of a prunings pile located on waterward side looking upstream.

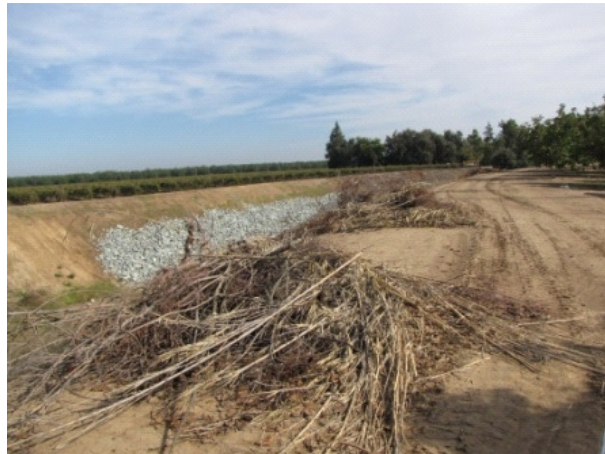
Levee Mile Report Line	40
Start Levee Mile	9.01
End Levee Mile	9.01
Location	Water Side
Category	Earthen Levee
Item	Encroachments

View of prunings piles located on waterward side looking upstream.

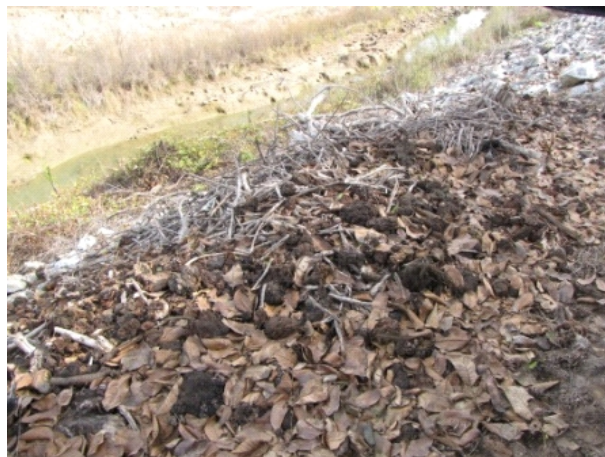
Levee Mile Report Line	42
Start Levee Mile	9.99
End Levee Mile	9.99
Location	Water Side
Category	Earthen Levee
Item	Encroachments

View of prunings on waterward side looking upstream.

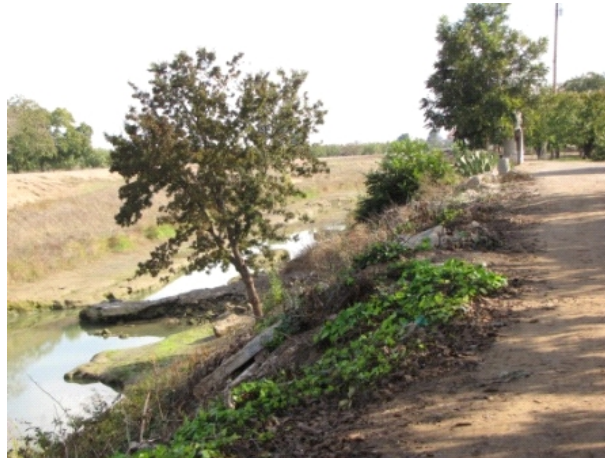
View of landscaping on waterward side looking upstream.

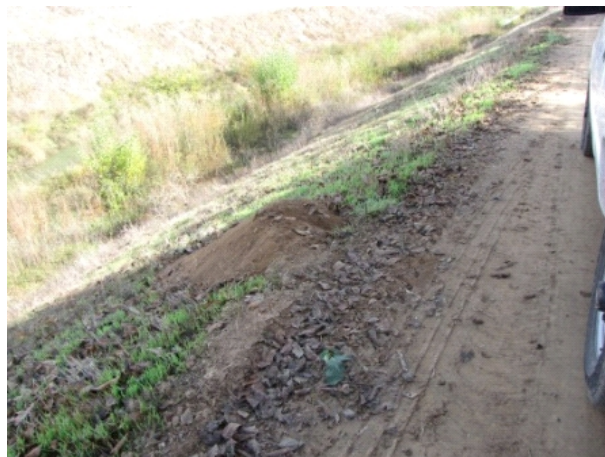
Levee Mile Report Line	45
Start Levee Mile	11.00
End Levee Mile	11.00
Location	Water Side
Category	Earthen Levee
Item	Animal Control

View of rodent activity on waterward side looking upstream.

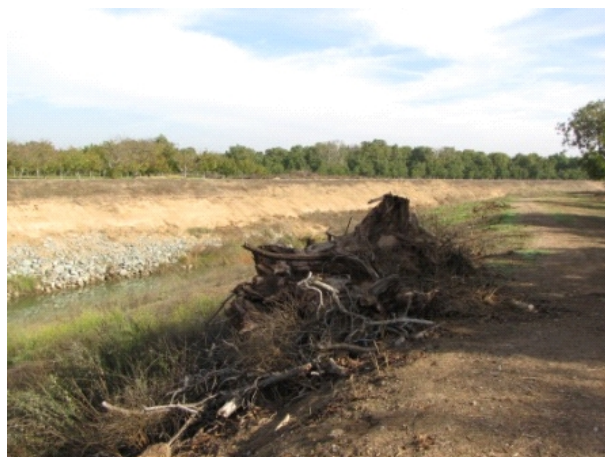
Levee Mile Report Line	46
Start Levee Mile	11.07
End Levee Mile	11.07
Location	Water Side
Category	Earthen Levee
Item	Encroachments

View of prunings located on waterward side looking upstream.

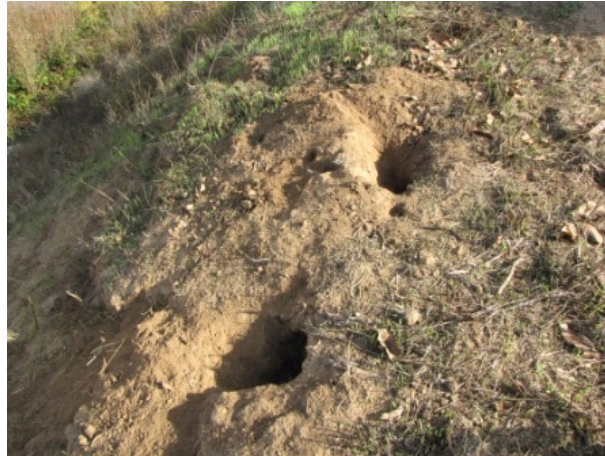
View of typical rodent holes on waterward side.

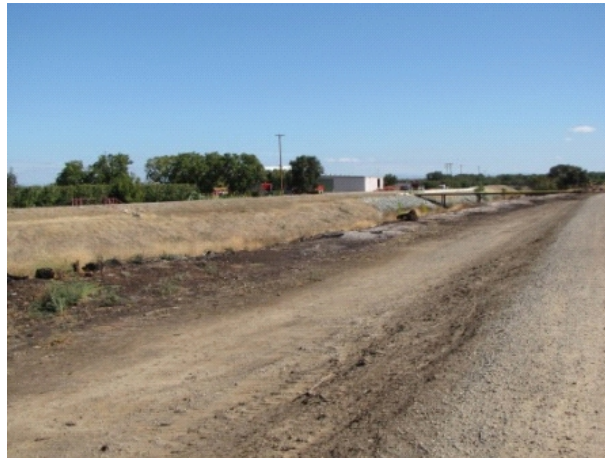
View of burn piles along the waterward berm encouraging rodents and damaging the berm of the channel.

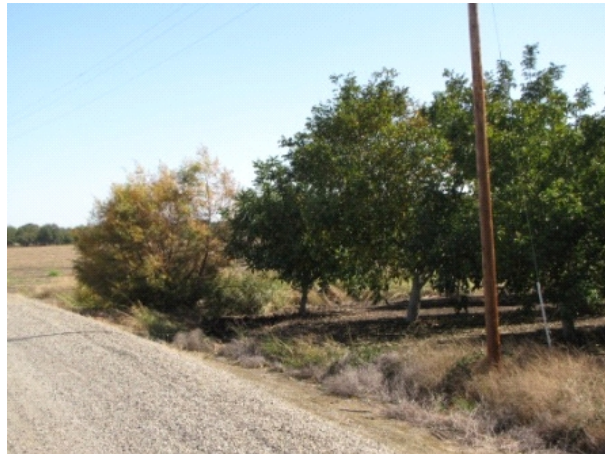
Levee Mile Report Line	55
Start Levee Mile	12.59
End Levee Mile	12.59
Location	Land Side
Category	Earthen Levee
Item	Vegetation

view of excessive vegetation blocking visibility and access along the landward toe looking upstream.

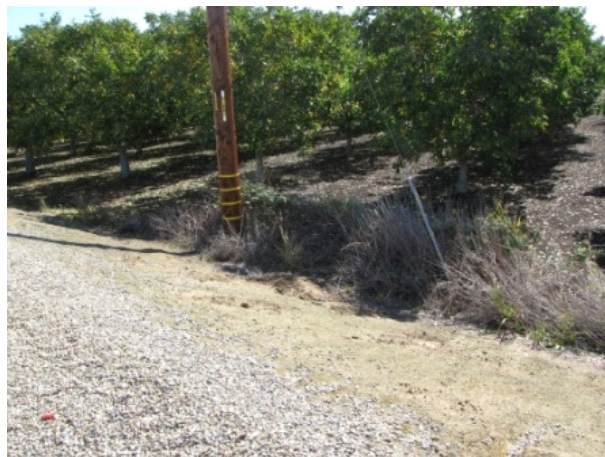
Levee Mile Report Line	56
Start Levee Mile	12.66
End Levee Mile	12.66
Location	Land Side
Category	Earthen Levee
Item	Vegetation

View of excessive vegetation along the landward toe blocking visibility and access.

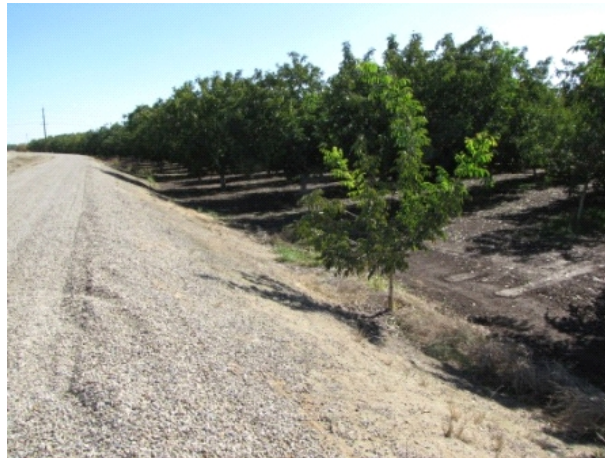
View of a tree planted at the landward toe looking upstream. This tree appears to be planted by the farmer.

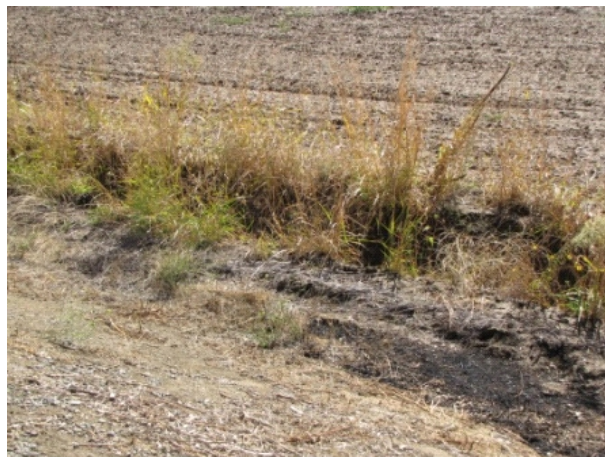
Levee Mile Report Line	58
Start Levee Mile	12.96
End Levee Mile	13.16
Location	Land Side
Category	Earthen Levee
Item	Encroachments

View of an irrigation/drainage ditch along the landward toe.

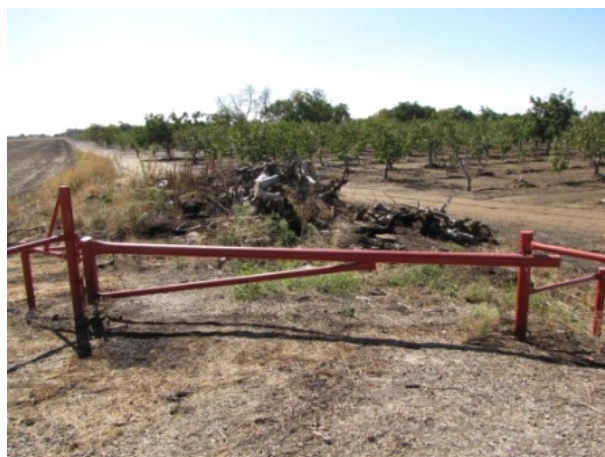
Levee Mile Report Line	59
Start Levee Mile	13.17
End Levee Mile	13.17
Location	Land Side
Category	Earthen Levee
Item	Encroachments

View of a prunings pile along the landward toe of an access ramp. Pile is blocking access through this gate.

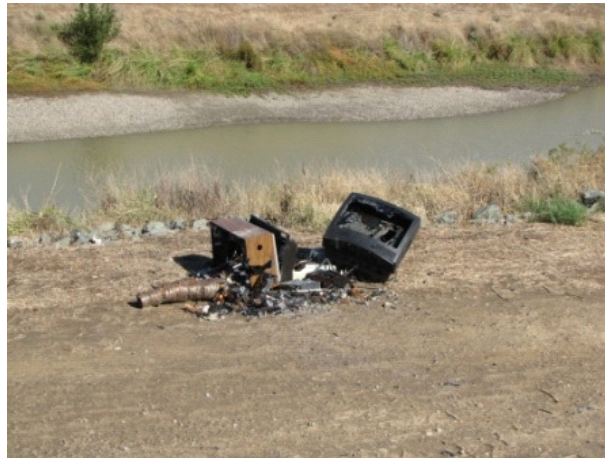
View of a debris pile along the waterward berm.

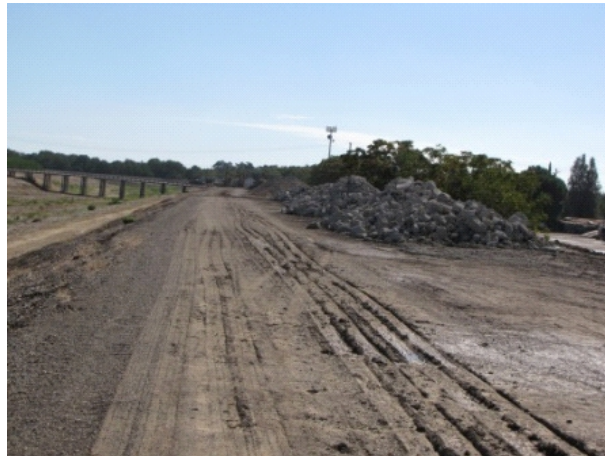
Levee Mile Report Line	62
Start Levee Mile	14.01
End Levee Mile	14.10
Location	Crown
Category	Earthen Levee
Item	Crown Surface / Depressions / Rutting

View of crown of the levee where gravel has been graded away. Vehicle tracks and rutting can be seen.

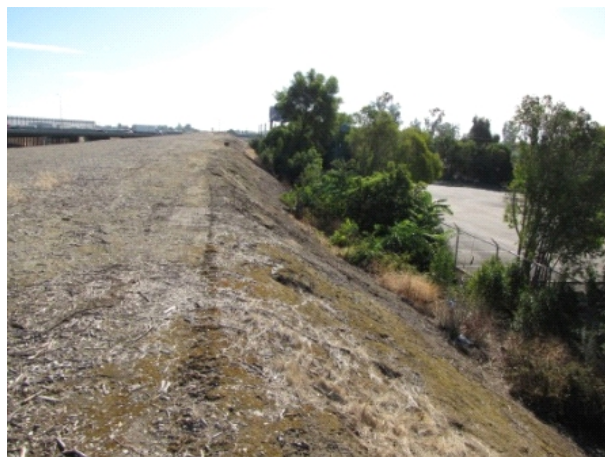
dpesaven_20091026_211.jpg

View of excessive vegetation along the landward slope blocking visibility and access looking upstream.

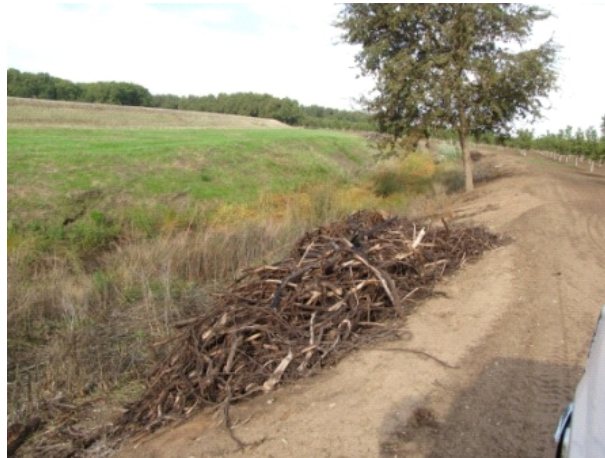
dpesaven_20091026_210.jpg

View of prunings placed on the waterward slope looking upstream.

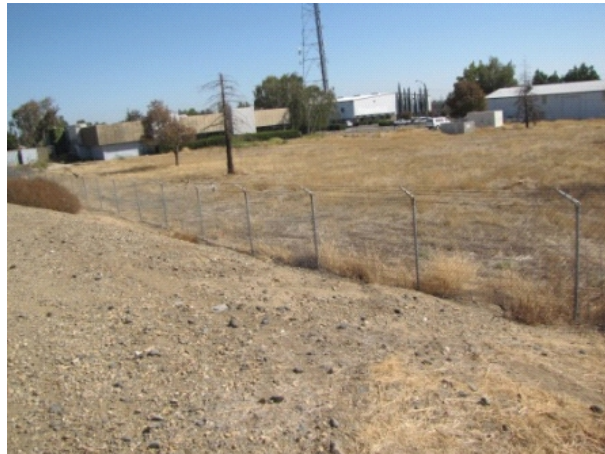
Levee Mile Report Line	67
Start Levee Mile	19.00
End Levee Mile	19.20
Location	Land Side
Category	Earthen Levee
Item	Encroachments

View of a fence along the landward toe looking upstream.

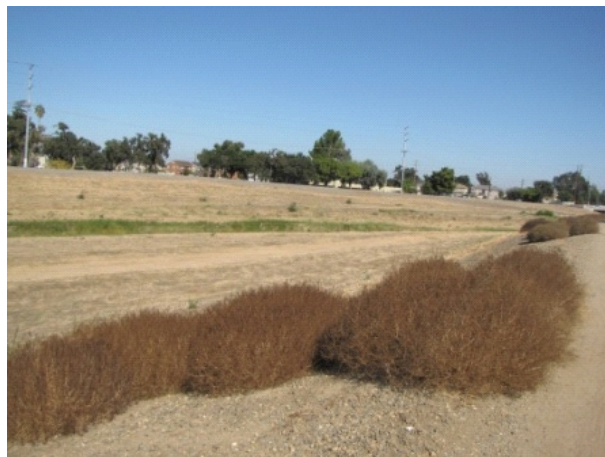
Levee Mile Report Line	68
Start Levee Mile	19.11
End Levee Mile	19.16
Location	Water Side
Category	Earthen Levee
Item	Vegetation

View of excessive vegetation along the waterward slope blocking visibility and access looking upstream.

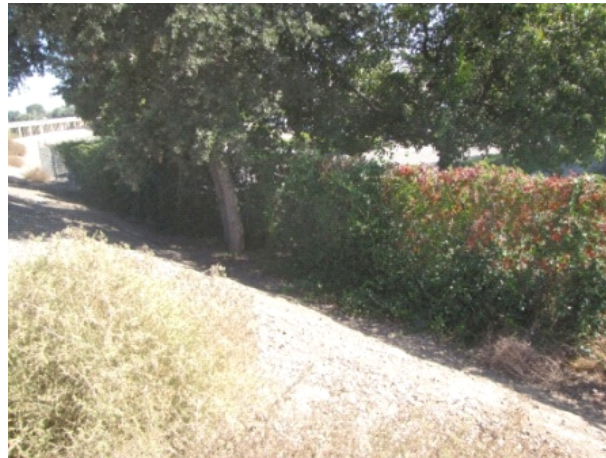
dpesaven_20091026_209.jpg

View of landscaping along the landward toe.

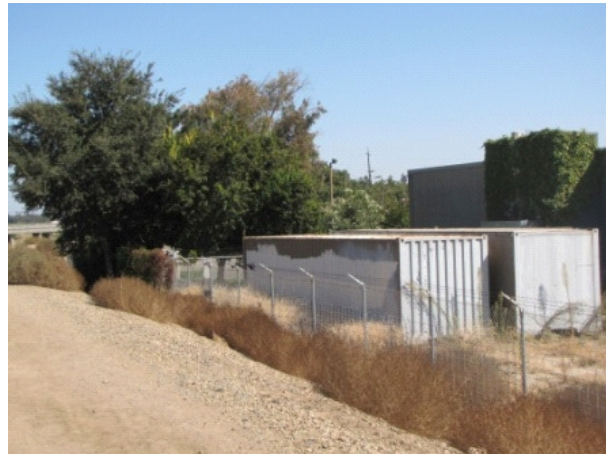
Levee Mile Report Line	70
Start Levee Mile	19.14
End Levee Mile	19.16
Location	Land Side
Category	Earthen Levee
Item	Vegetation

View of excessive vegetation blocking visibility and access along the landward slope looking upstream.

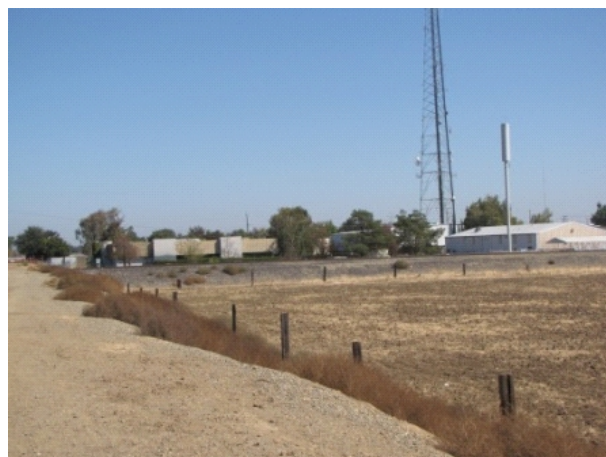
Levee Mile Report Line	71
Start Levee Mile	19.24
End Levee Mile	19.30
Location	Land Side
Category	Earthen Levee
Item	Vegetation

View of excessive vegetation along the landward slope blocking visibility and access looking upstream.

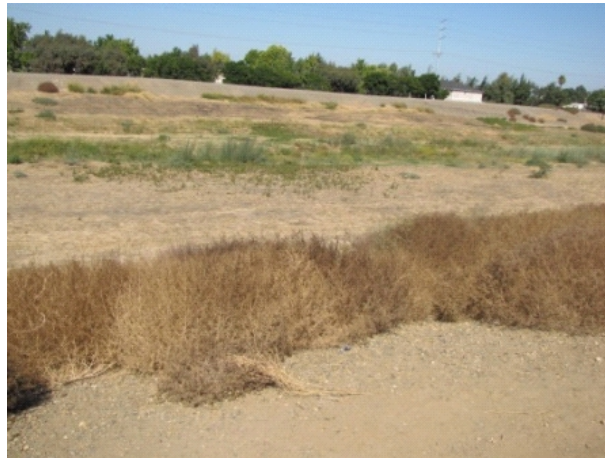
dpesaven_20091026_204.jpg

View of excessive vegetation blocking visibility and access along the waterward slope.

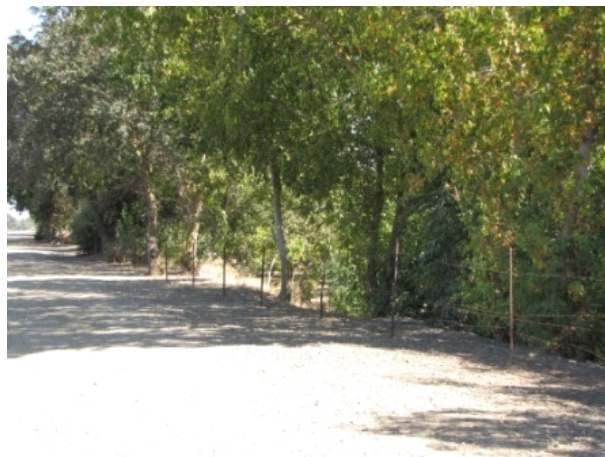
Levee Mile Report Line	73
Start Levee Mile	19.47
End Levee Mile	19.60
Location	Land Side
Category	Earthen Levee
Item	Encroachments

View of a barbed wire fence and landscaping along the landward shoulder and slope looking upstream.

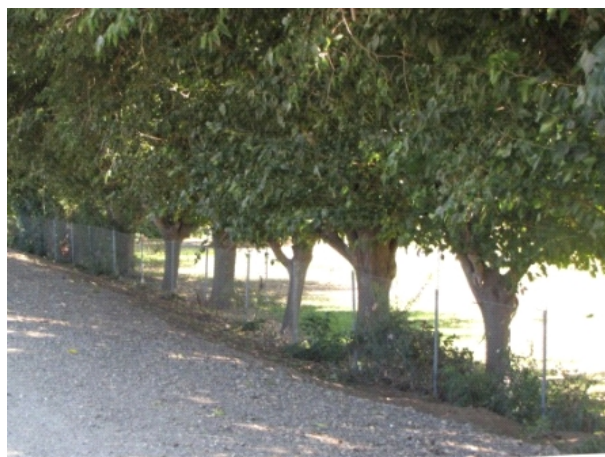
Levee Mile Report Line	77
Start Levee Mile	19.60
End Levee Mile	19.69
Location	Land Side
Category	Earthen Levee
Item	Encroachments

View of a fence along the landward slope looking upstream.

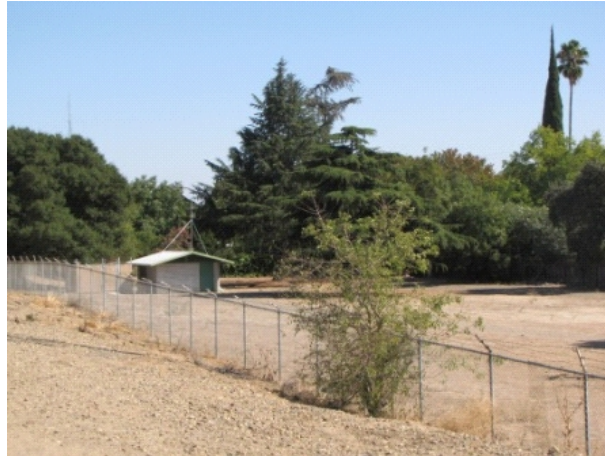
dpesaven_20091026_201.jpg

View of a fence along the landward toe looking upstream.

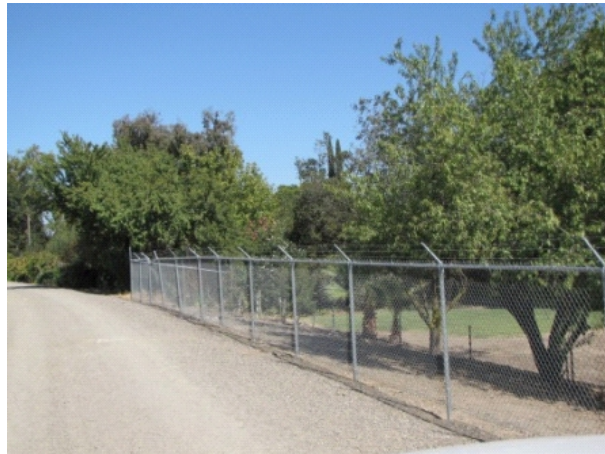
Levee Mile Report Line	98
Start Levee Mile	20.26
End Levee Mile	20.28
Location	Land Side
Category	Earthen Levee
Item	Encroachments

View of a fence along the landward slope looking upstream.

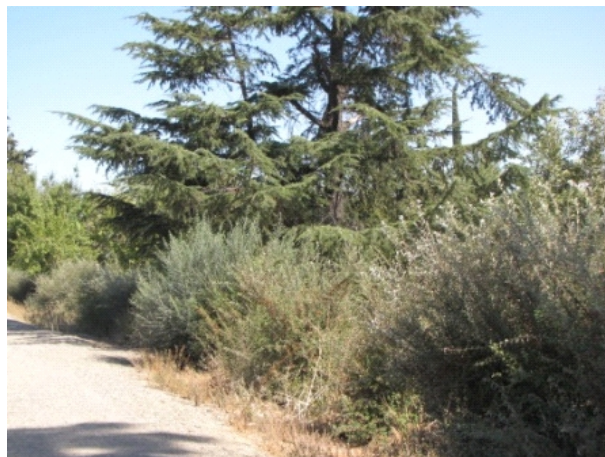
Levee Mile Report Line	100
Start Levee Mile	20.45
End Levee Mile	20.51
Location	Land Side
Category	Earthen Levee
Item	Vegetation

View of excessive vegetation along the landward slope blocking visibility and access looking upstream.

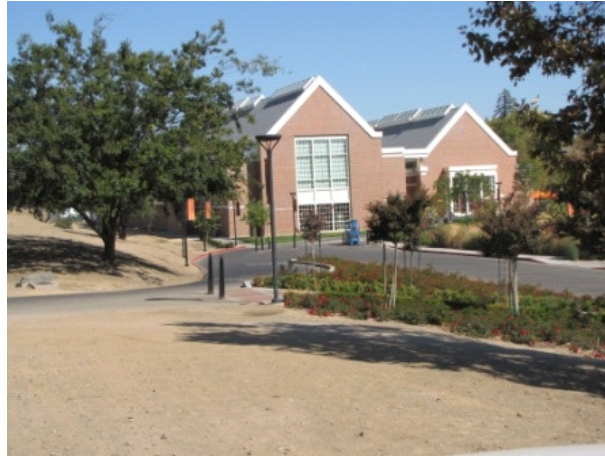
Levee Mile Report Line	101
Start Levee Mile	20.83
End Levee Mile	20.83
Location	Land Side
Category	Earthen Levee
Item	Encroachments
View of landscaping planted and maintained by UOP along the landward slope and toe looking upstream.	
dpesaven_20091026_198.jpg

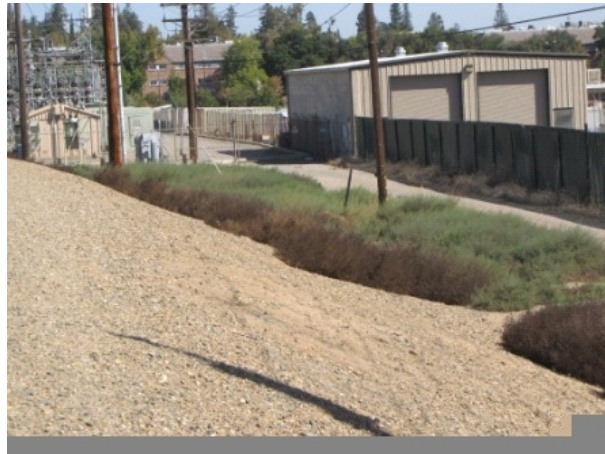
Levee Mile Report Line	102
Start Levee Mile	21.08
End Levee Mile	21.13
Location	Land Side
Category	Earthen Levee
Item	Vegetation
View of excessive vegetation along the landward toe blocking visibility and access.	
dpesaven_20091026_197.jpg

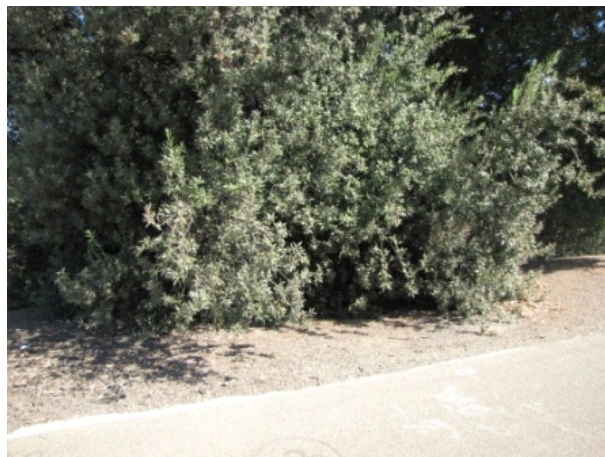
Levee Mile Report Line	106
Start Levee Mile	21.27
End Levee Mile	21.27
Location	Water Side
Category	Earthen Levee
Item	Trim / Thin Trees
View of trees along the waterward shoulder and slope blocking visibility and access.	
dpesaven_20091026_196.jpg

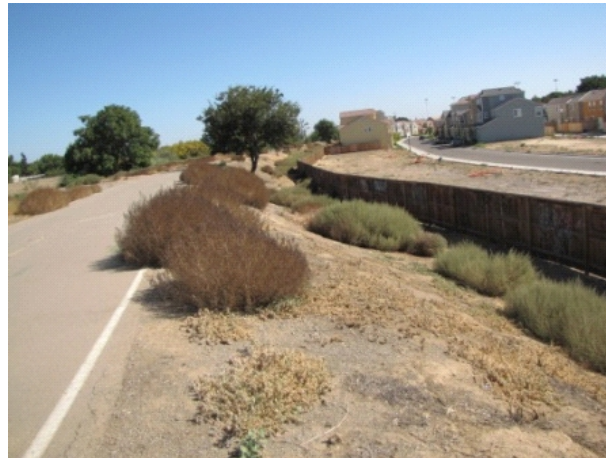
Levee Mile Report Line	107
Start Levee Mile	21.32
End Levee Mile	21.45
Location	Land Side
Category	Earthen Levee
Item	Vegetation
View of excessive vegetation along the landward slope looking upstream.	
dpesaven_20091026_194.jpg

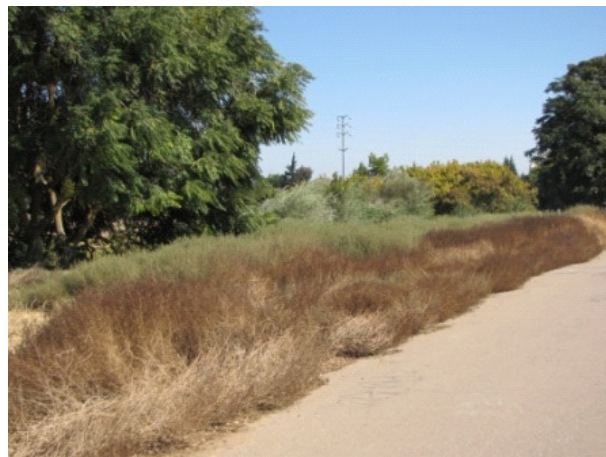
Levee Mile Report Line	108
Start Levee Mile	21.38
End Levee Mile	21.40
Location	Water Side
Category	Earthen Levee
Item	Vegetation
Excessive vegetation along the waterward shoulder and slope blocking visibility looking upstream.	
dpesaven_20091026_195.jpg

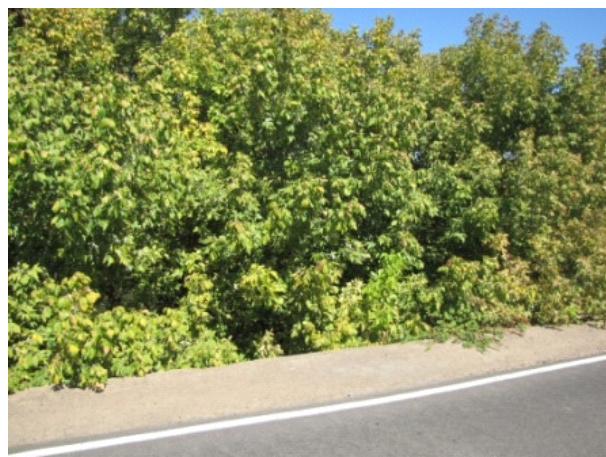
Levee Mile Report Line	122
Start Levee Mile	22.03
End Levee Mile	22.03
Location	Water Side
Category	Earthen Levee
Item	Trim / Thin Trees
View of trees along the waterward slope obstructing visibility and access.	
dpesaven_20091026_193.jpg

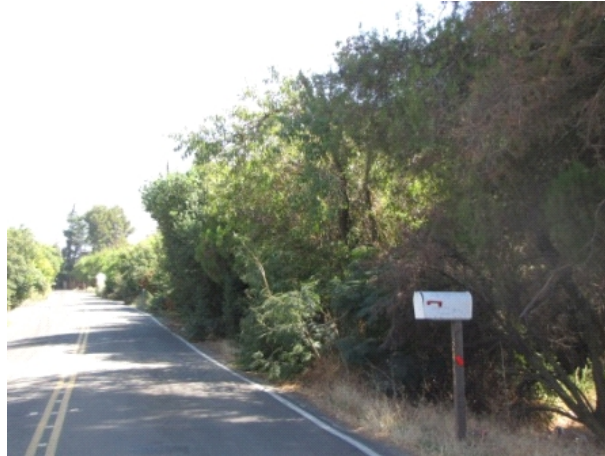
dpesaven_20091026_186.jpg

View of landscaping along landward slope looking upstream.

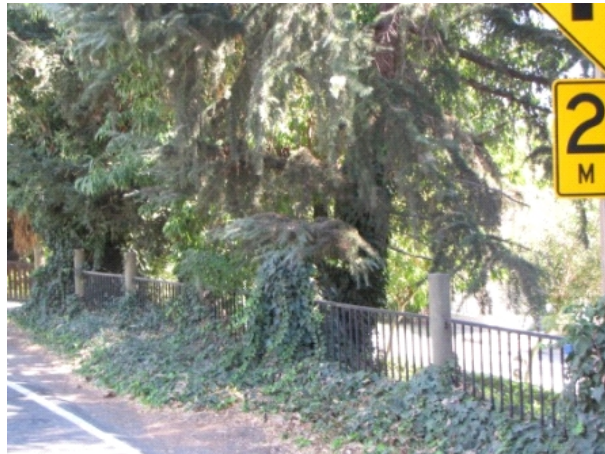
Levee Mile Report Line	129
Start Levee Mile	22.17
End Levee Mile	22.18
Location	Land Side
Category	Earthen Levee
Item	Encroachments

View of a fence and landscaping along the landward shoulder and slope looking upstream.

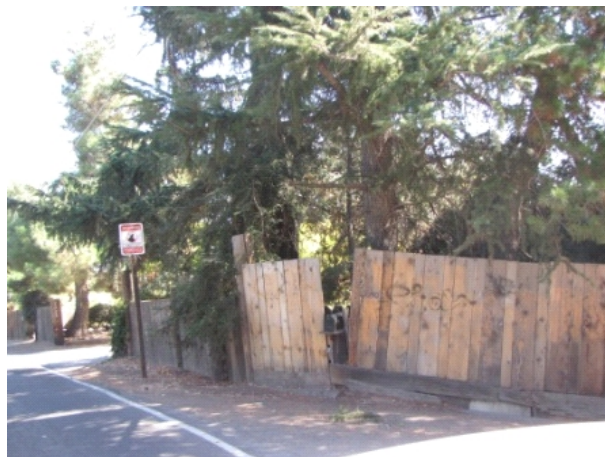
Levee Mile Report Line	131
Start Levee Mile	22.19
End Levee Mile	22.21
Location	Land Side
Category	Earthen Levee
Item	Encroachments

View of a fence along the landward shoulder and slope looking upstream.

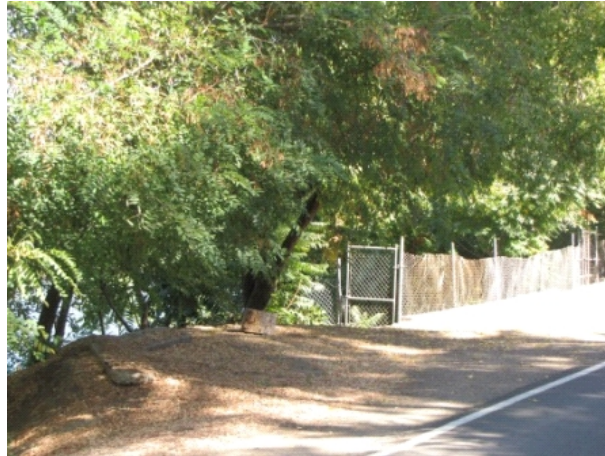
dpesaven_20091026_191.jpg

View of a fence along the waterward shoulder and slope looking upstream.

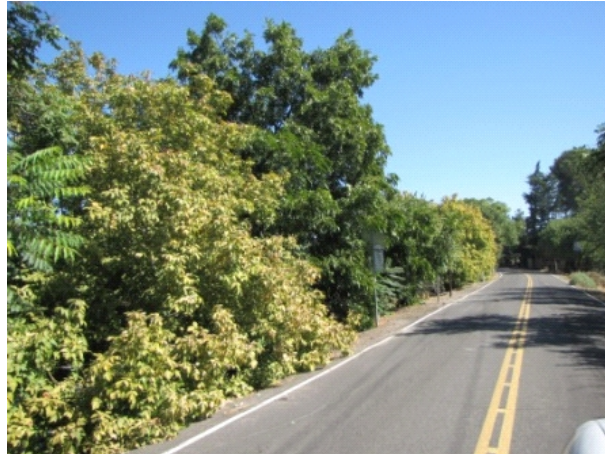
Levee Mile Report Line	135
Start Levee Mile	22.21
End Levee Mile	22.28
Location	Water Side
Category	Earthen Levee
Item	Trim / Thin Trees

View of trees along the waterward slope obstructing visibility and access looking upstream.

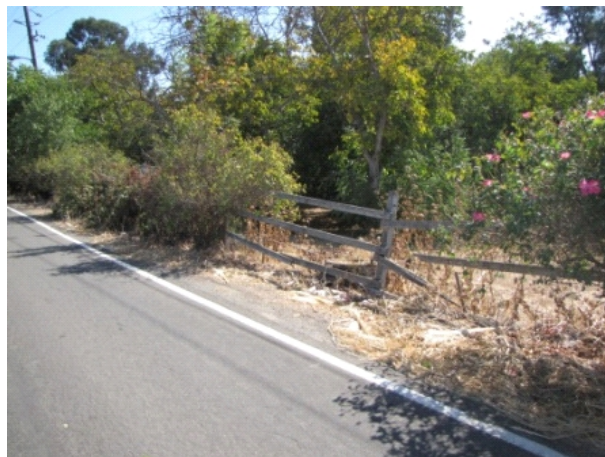
Levee Mile Report Line	136
Start Levee Mile	22.26
End Levee Mile	22.30
Location	Land Side
Category	Earthen Levee
Item	Encroachments

View of a fence along the landward shoulder looking upstream.

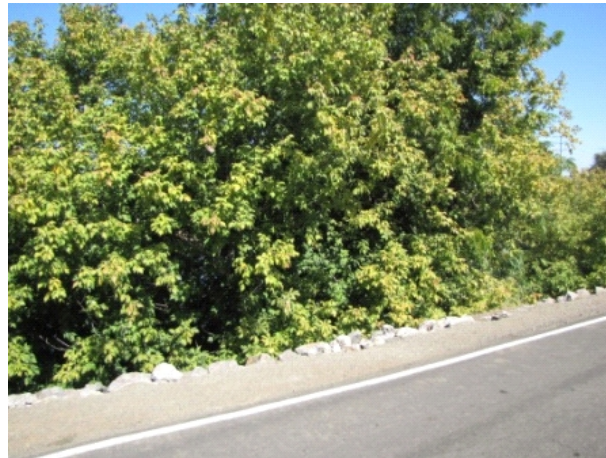
dpesaven_20091026_187.jpg

View of trees on the waterward slope obstructing visibility and access looking upstream.

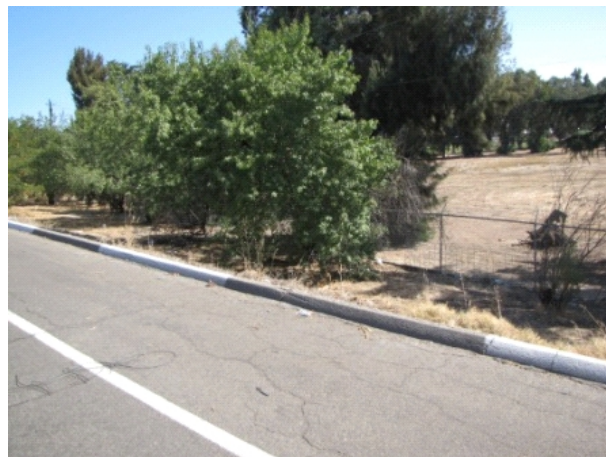
Levee Mile Report Line	138
Start Levee Mile	22.37
End Levee Mile	22.43
Location	Land Side
Category	Earthen Levee
Item	Encroachments

View of fence and landscaping along landward slope looking upstream.

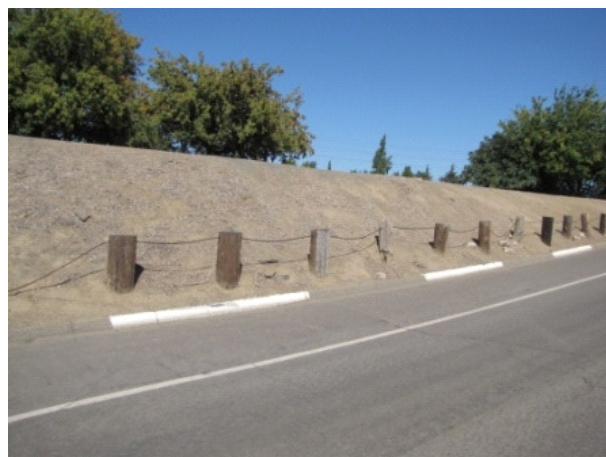
Levee Mile Report Line	139
Start Levee Mile	22.43
End Levee Mile	22.46
Location	Land Side
Category	Earthen Levee
Item	Encroachments

View of a post and cable fence along the landward slope looking upstream.

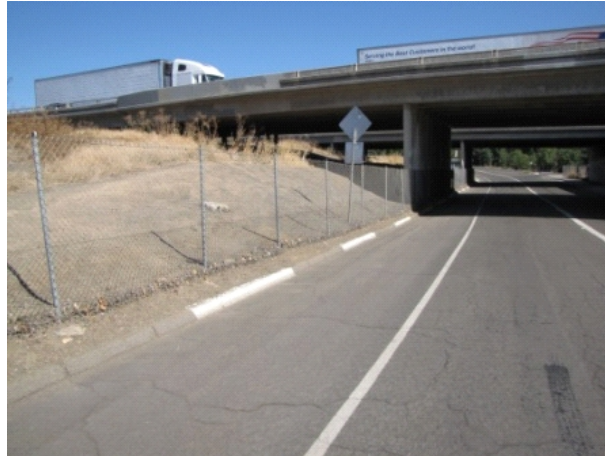
dpesaven_20091026_183.jpg

View of fence along landward toe looking upstream.

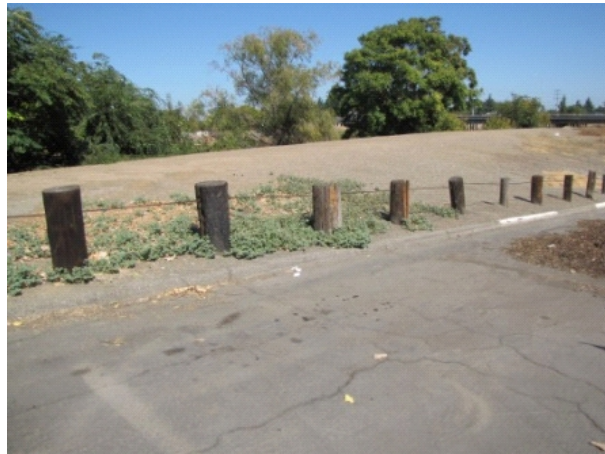
Levee Mile Report Line	141
Start Levee Mile	22.52
End Levee Mile	22.57
Location	Land Side
Category	Earthen Levee
Item	Encroachments

View of post and cable fence along the landward levee slope looking upstream.

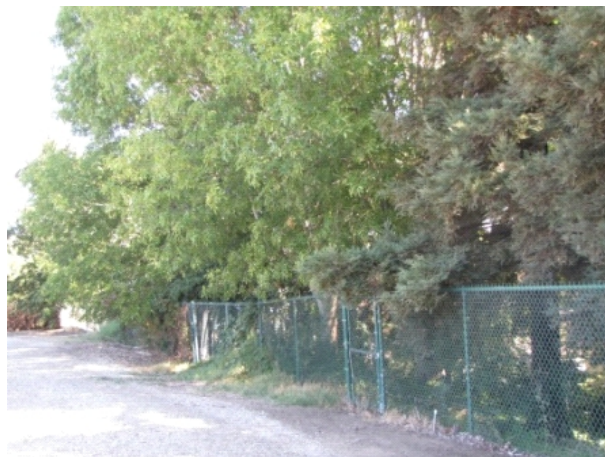
Levee Mile Report Line	144
Start Levee Mile	22.58
End Levee Mile	22.87
Location	Land Side
Category	Earthen Levee
Item	Encroachments

View of fence and landscaping along the landward shoulder and slope looking upstream.

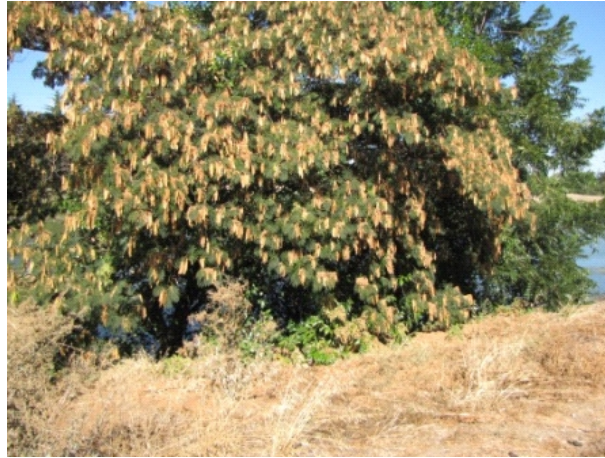
dpesaven_20091026_181.jpg

View of a tree blocking visibility and access along the waterward slope.

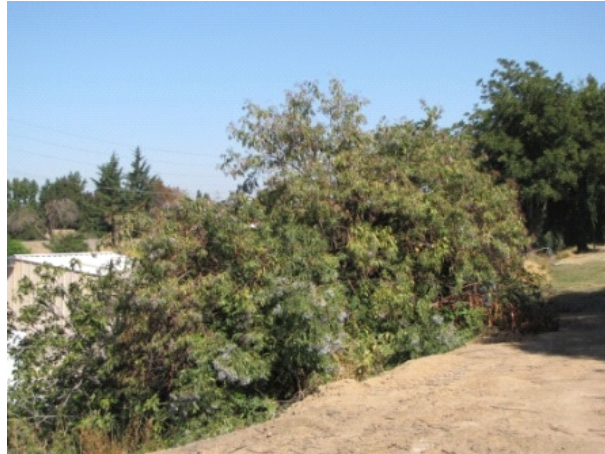
Levee Mile Report Line	146
Start Levee Mile	22.86
End Levee Mile	22.86
Location	Land Side
Category	Earthen Levee
Item	Vegetation

View of elderberry bushes along the waterward slope looking upstream.
